Permit 2024-0318 Final Report

Hampden P5433 Wreck Site (DeRu-214)
compass recovery

Submitted to the Archaeology Branch
July 2025

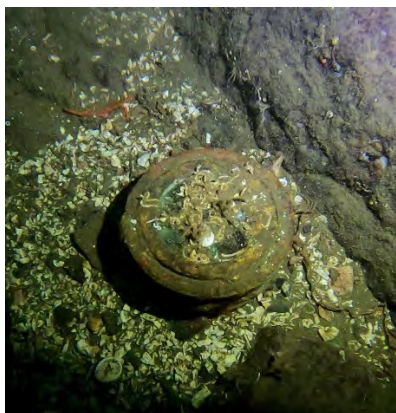
Photo 1. Compass in situ.

On November 9, 2024, the UASBC visited the crash site to place an underwater memorial plaque on the site to commemorate the crash and the four crew members who perished. During the dive to place the plaque, the compass location was re-surveyed, and the compass was *photographed in situ* (Photo 1). Once this was complete the compass was moved carefully into an enclosed plastic container and placed in a diver’s mesh bag for recovery. A marker float was released at the compass location so that an accurate GPS location could be taken. The recorded coordinates for the compass are 48 40 .242N x 123 29 .332W.

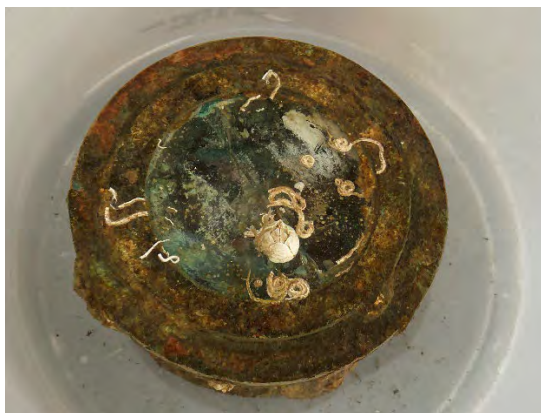
Photo 2. Compass in seawater on board the dive boat.

The compass was brought to the surface slowly to minimize any damage from moving it. Once onboard the dive boat, the compass was kept in seawater and photographed to record its condition (Photo 2).

Leslie Hickey of the Parks Canada Marine Conservation Team provided advice on how to deal with the compass after recovery. Following her instructions, the compass has been kept submerged completely in a container with a lid in seawater. After two weeks, the UASBC began exchanging the sea water for tap water. For the duration of this process the compass has been kept in a cool dark location.

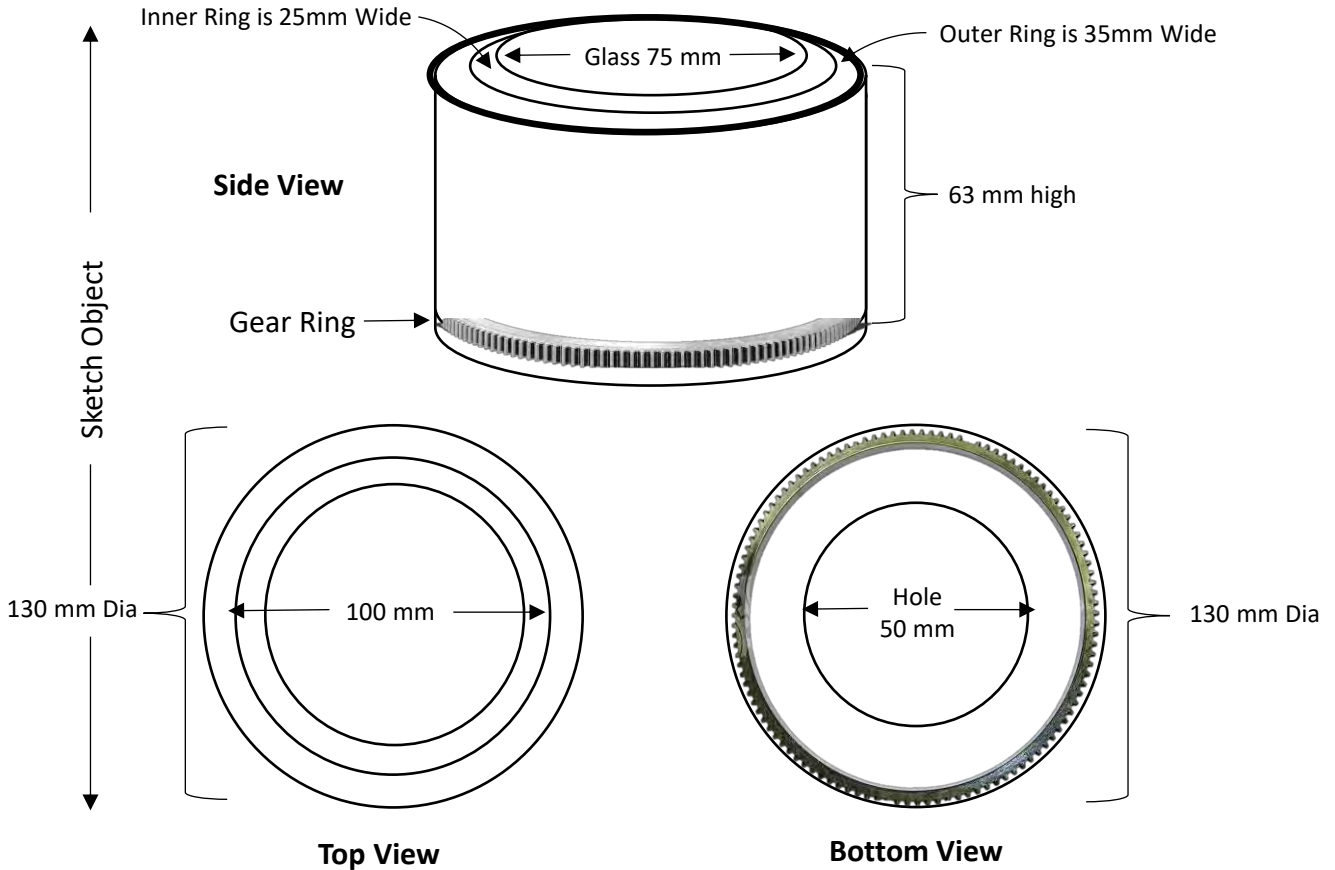
3. Sketch object with measurements below. (Record dimensions in millimeters)

The compass is a single piece but is made up of several components. There is an outer brass ring that is 30 mm wide. Inside of the outer ring is a second thinner 25 mm wide brass ring. The center of the compass is defined by a 75 mm diameter glass face piece. The compass is 62 mm high. There is a 50 mm diameter hole in the base. A gear like apparatus encircles the bottom of the compass 3 mm above the base. The compass has a 3 mm raised lip on the top.

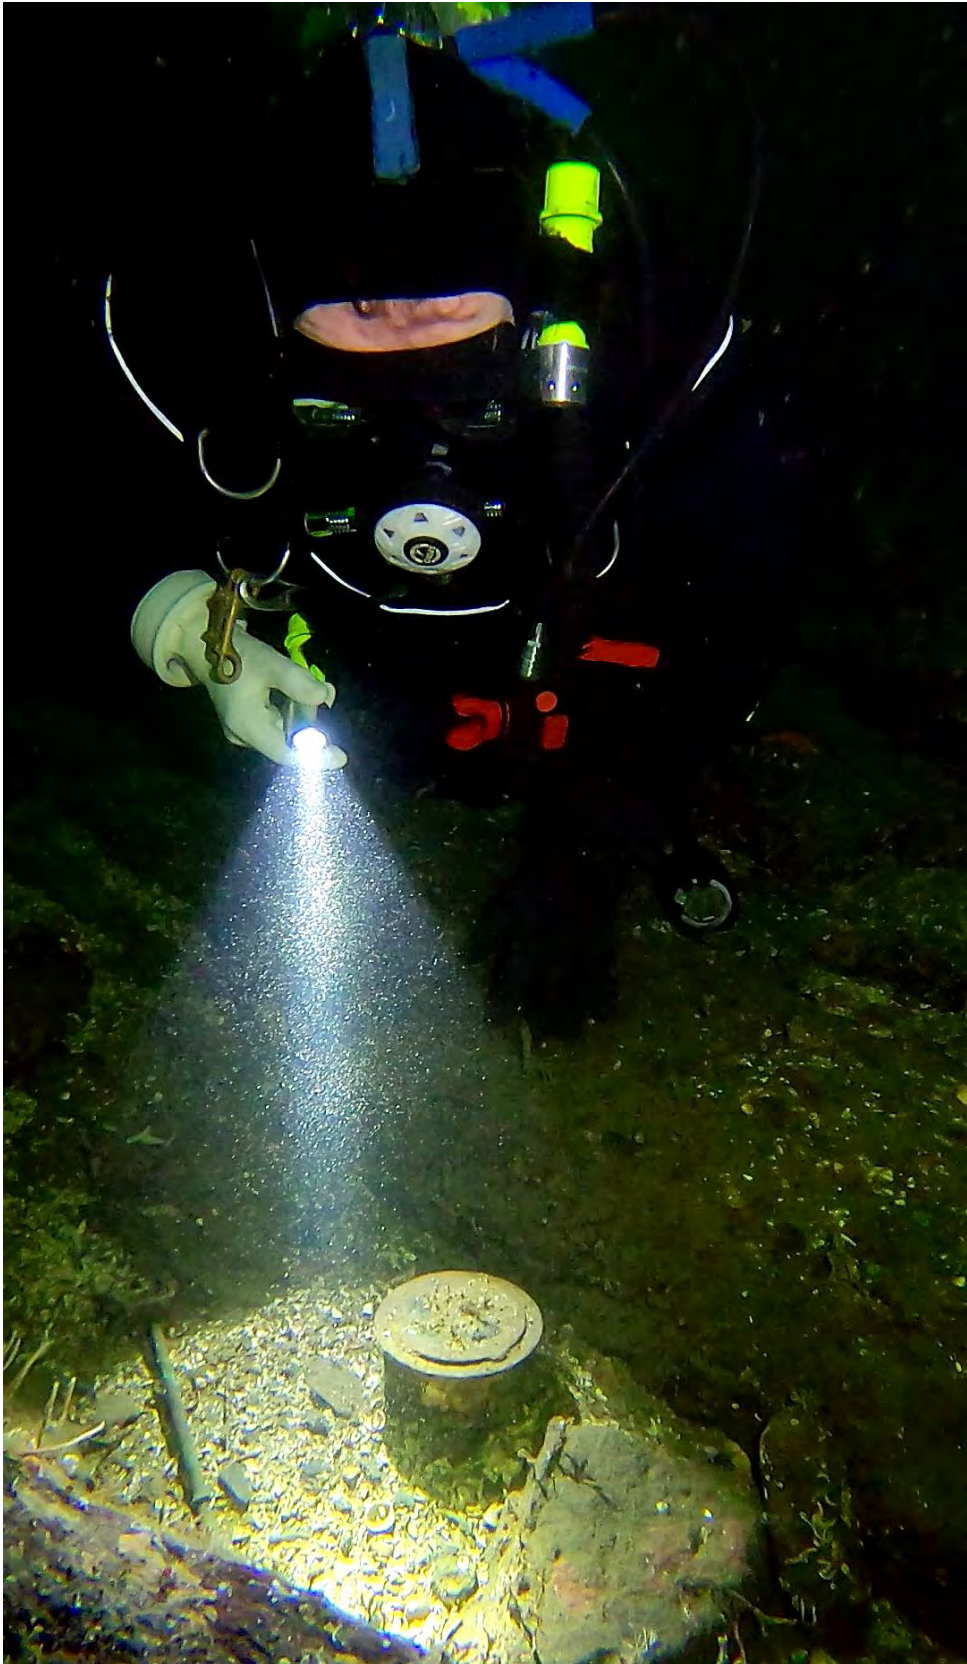
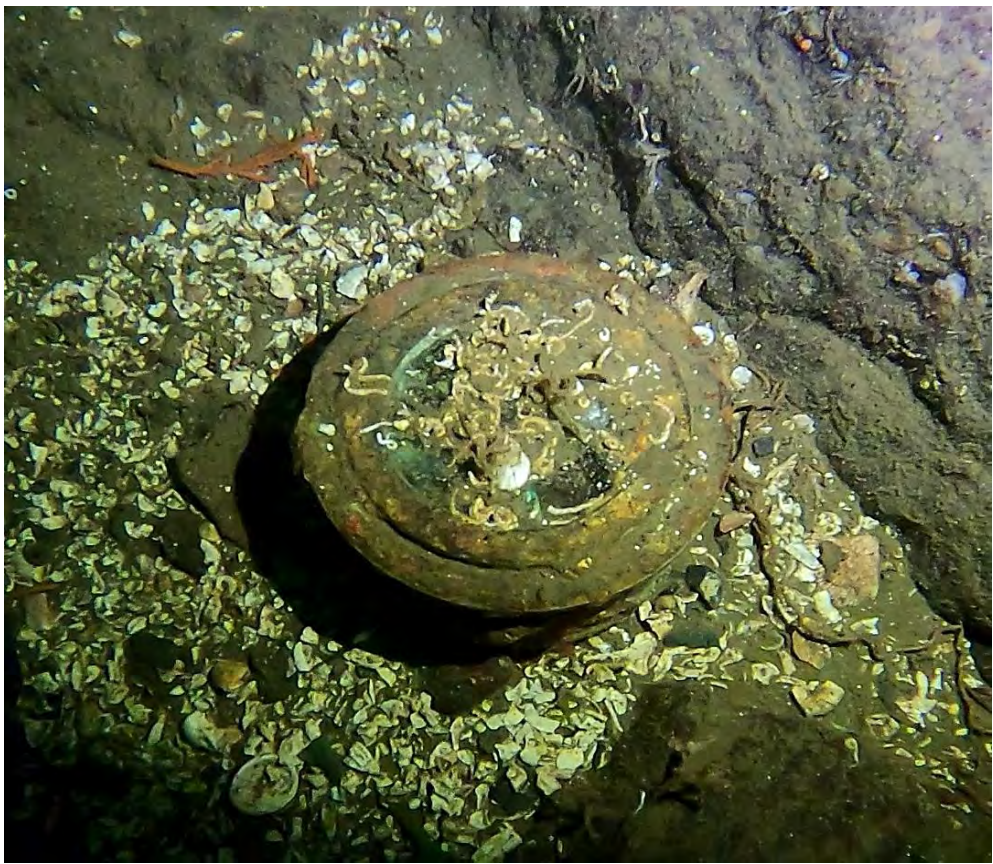
Hampden P5433 Compass in situ on the bottom.

The compass is in quite fragile condition. The base has corroded through and there are marine worms and a barnacle growing on the external surface. The opening in the base has allowed seawater to enter the inside of the compass and it has displaced the original oil and corroded the compass card. There are vestiges of the navigation arrow visible under the glass.

The compass was found on a sand shell bottom between rock outcrops. The compass was found 9.1 meters on a 60 degree bearing from the landing gear axel. The GPS coordinates are 48 40 .242 N x 123 29 .332W
